Maryland Historical Trust

Maryland Inventory of Historic Properties Historic Bridge Inventory Maryland State Highway Administration Maryland Historical Trust

Name and SHA No. M 46 over Little Monocacy River

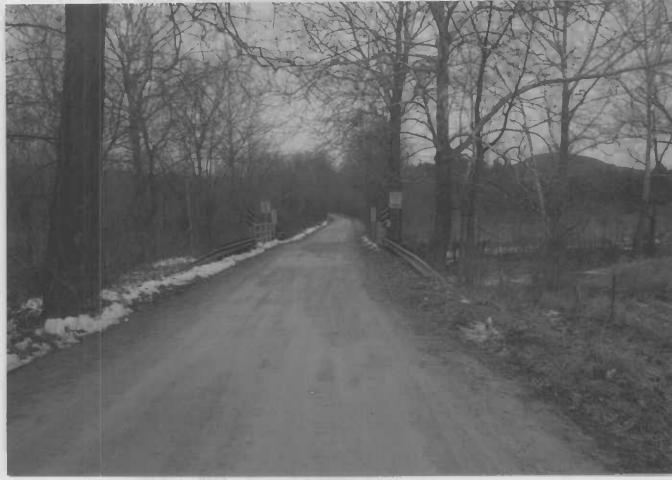
Inventory # M: 12-49

LITTLE MONOCACE
Name MHG - WEST HARRIS ROOVER RIVER
County/State Montgomery mp
Name of Photographer FRANK JULIANO
Date 2 95
Location of Negative SHR
Description APPROACH NORTH
Number 4 of 26

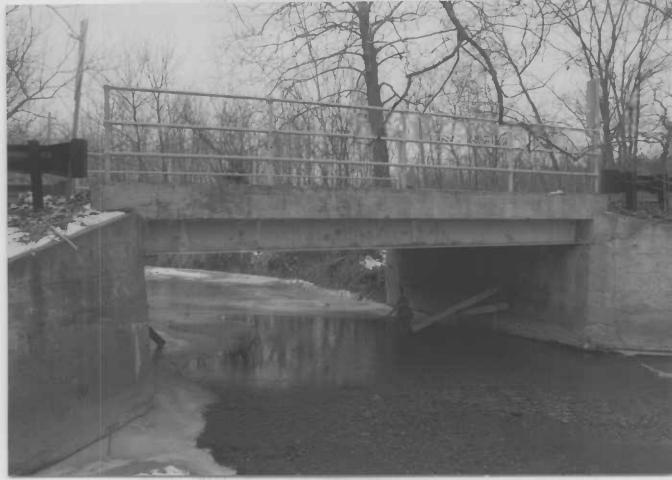
Inventory # M: 12-49

Name M46 - WEST HARRIS RO OVER LITTLE MONOCACY RIVER
County/State Montoomery / mo
Name of Photographer FRANK JUNIANO
Date 295
Location of Negative SHR
Description ELEVATION WEST
<u> </u>
A
Number 5 of 35

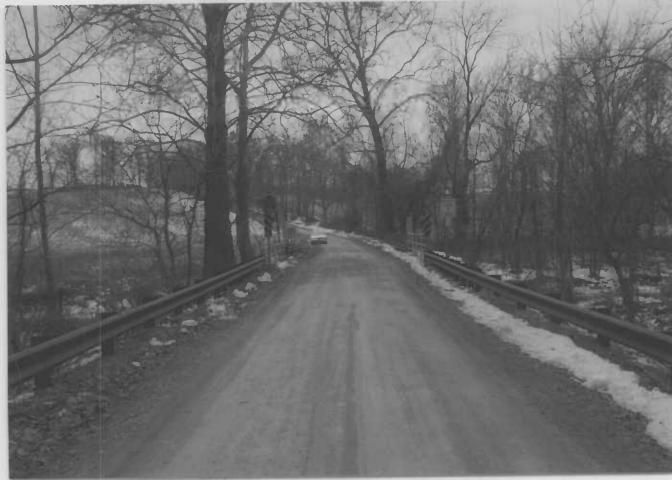
Inventory # M112-49

Name M46-WEST HARRIS ROOVER LITTLE MONOCLACY RIVER
County/State Montoomery mo
Name of Photographer FRANK JULIANO
Date 2 95
Location of Negative SHR
Description APPROACH SOUTH
3 4
Number 6 of 36

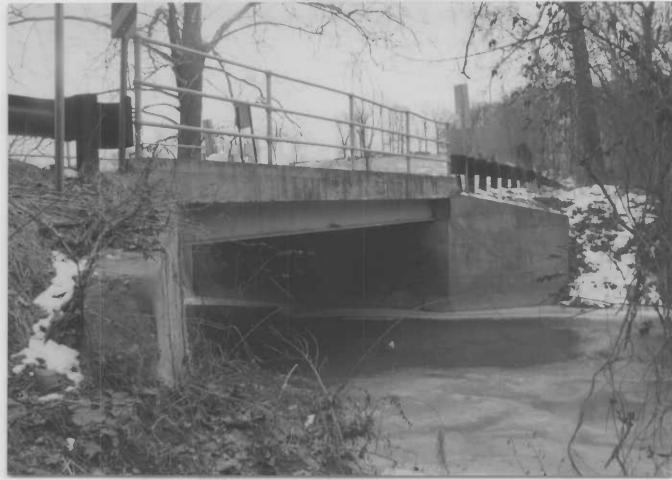
Inventory # M: 12-49

Name M46-WEST HARRIS RD OVER MONOCACY RIVER
Name 1146-WEST HARRIS KD OVER MONOCACY KIVER
County/State Moratsomery mp
Name of Photographer FRANK JULIANO
Date 2/95
Location of Negative SHA
Description ELEVATION EAST
Number 4 of 30
